New York State Department of Transportation

Yellow Flag NB23U4W011

BIN: 1065318

Location: Span 255, Girder G1 at Pier 254

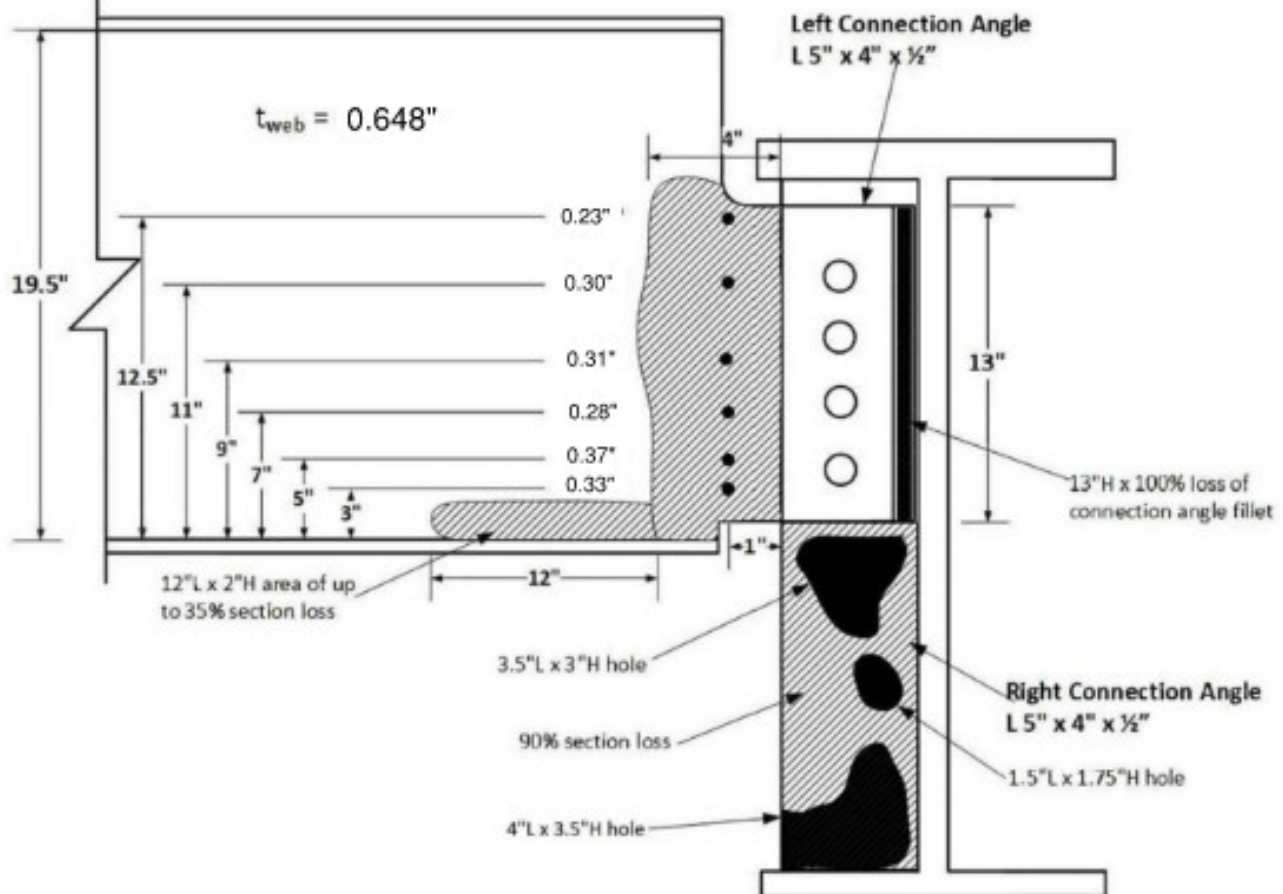
Photo Number: 2

Description: Girder G1 web along the connection angles exhibits 54% overall section loss (previously noted as 55% section loss) for the full height of the web. Additionally, the left connection angle exhibits full height, 100% section loss along the fillet of the connection angle. The right connection angle of Girder G1, from the bottom cope of the web of Girder G1 to the top cope of the web of Girder G1 has up to 20% section loss on full face with a 2"L x 2"H triangle area exhibiting 100% section loss in upper right corner. However, the right connection angle continues to provide a positive connection for the girder to the pier cap. The right connection angle below the bottom cope of the Girder G1 web, exhibits up to 90% section loss with three holes measuring 3.5"L x 3"H, 1.5"L x 1.75"H and 4"L x 3.5"H.

Section Loss Calculations:

Original Girder Web Thickness = 0.648" (as measured in the field)

As Built shearing web area = 13" H x 0.648" T = 8.42 sq. in.

Average remaining web section = $[0.33 \times 3"] + [0.37 \times 2"] + [0.28 \times 2"] + [0.31 \times 2"] + [0.30 \times 2"] + [0.23 \times 1.5"]$
 = 3.97 sq. in.

Web section loss – $((8.42 - 3.97)/8.42) \times 100\% = 54.21\%$ SAY = 54%

SKETCH FOR YELLOW # NB23U4W011
SPAN 255, GIRDER G1 AT PIER 254
(LOOKING RIGHT)
N.T.S

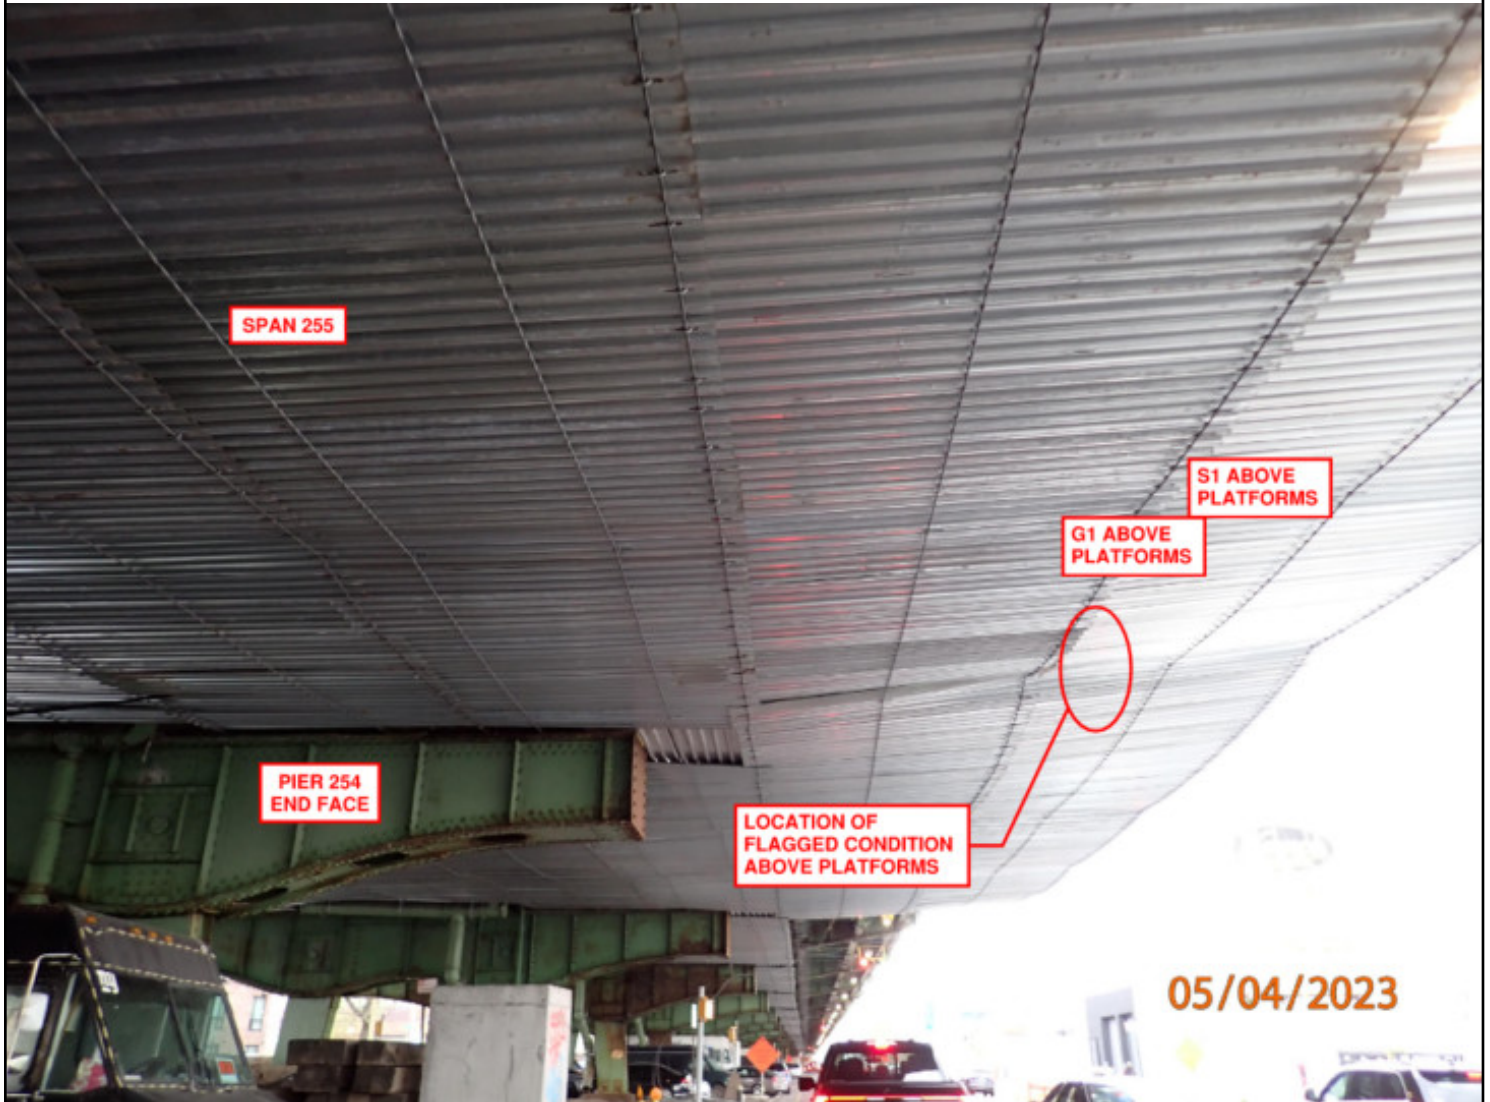
Photo Number: 3

Attachment Description: Span 255, Girder G1 at Pier 254. General view of the flagged location at Pier Cap connection, above platforms. Looking Begin-Up.

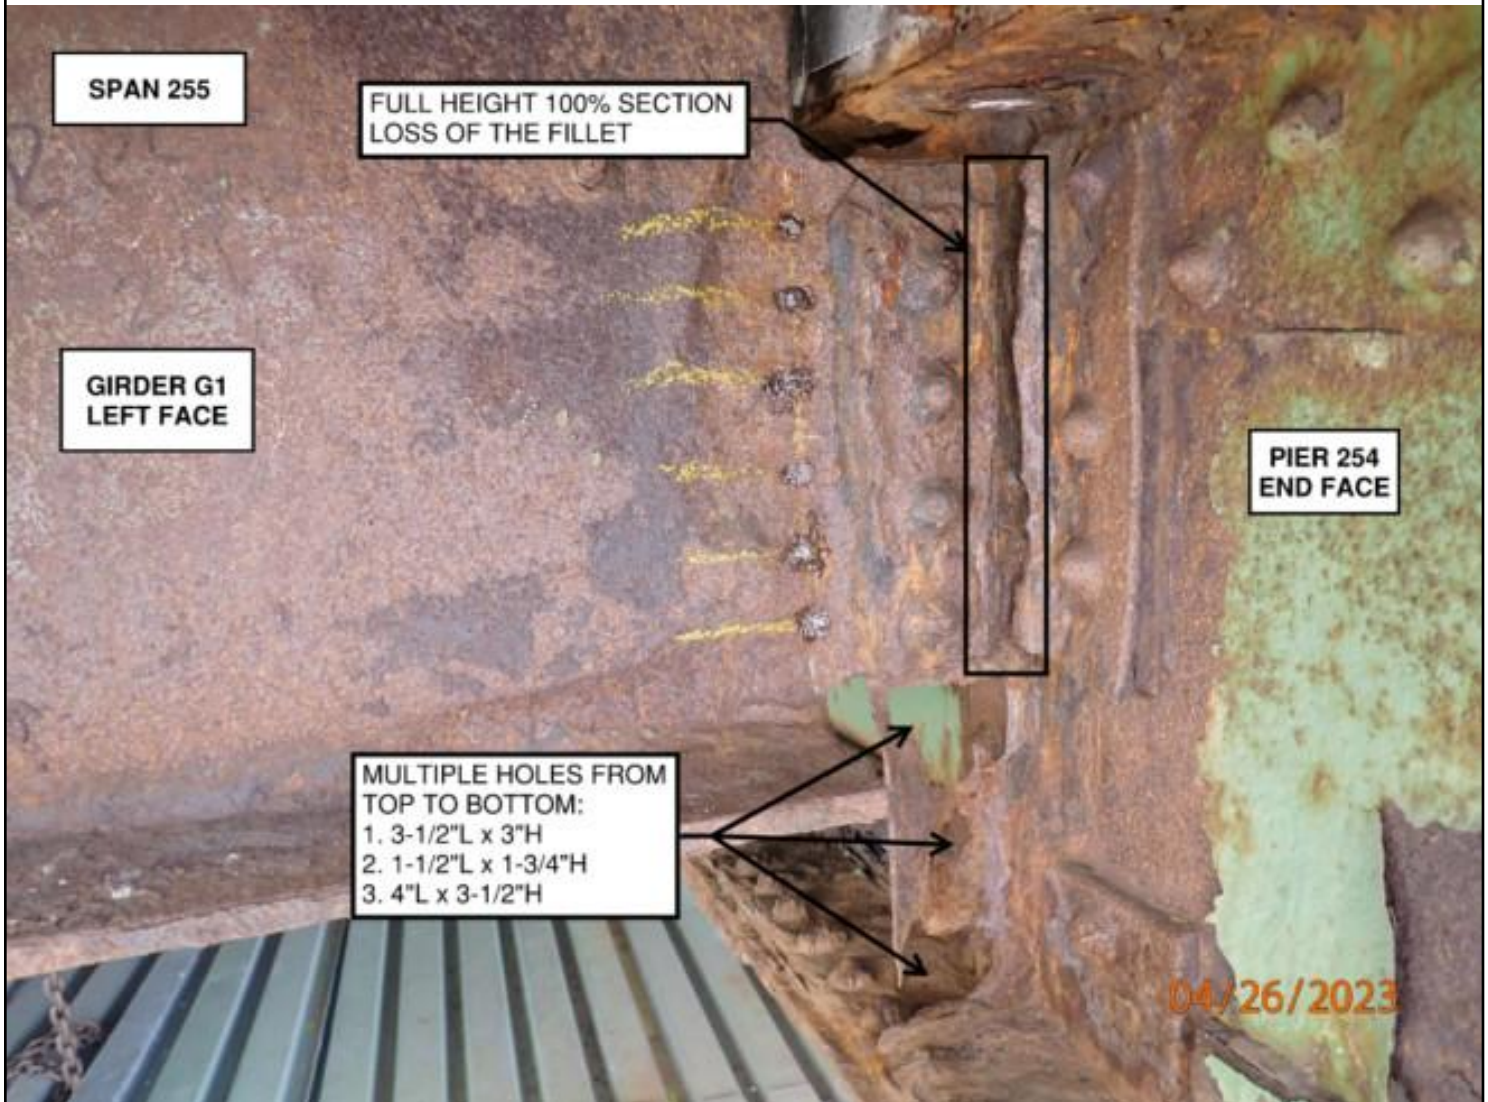
Photo Number: 4

Attachment Description: Close-up view of Girder G1 end showing heavy section loss to the girder web and corrosion holes in the right connection angle. Looking Begin-Right.

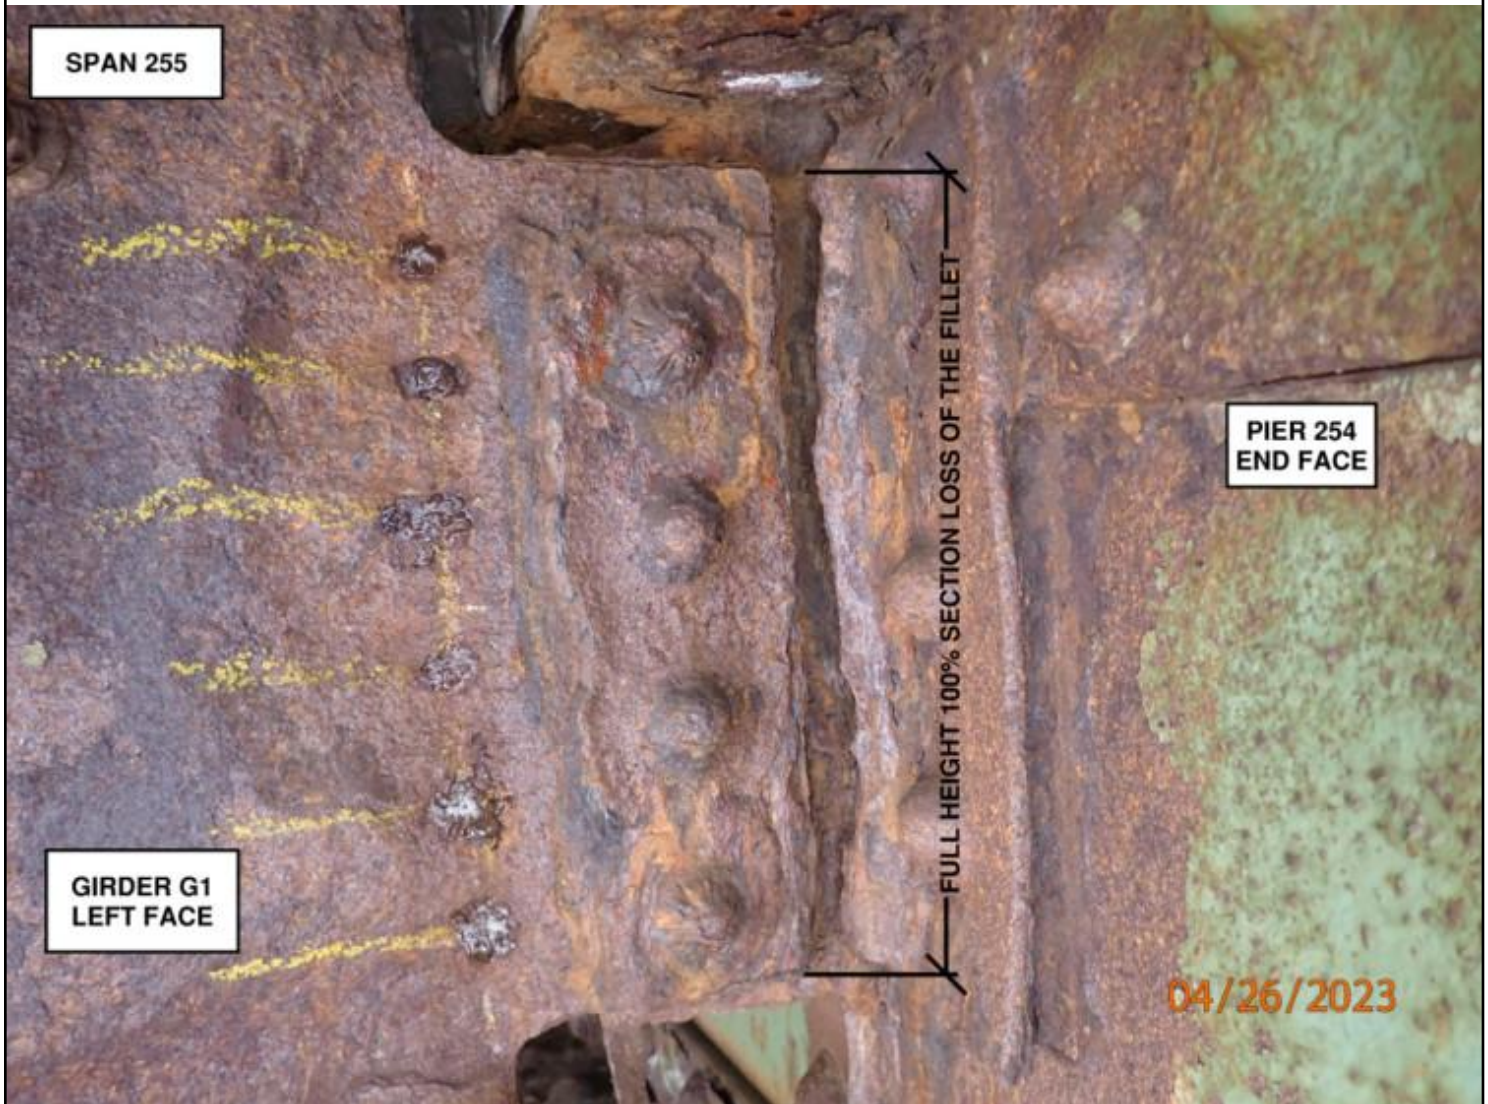
Photo Number: 5

Attachment Description: Close-up view of the full height 100% section loss along the fillet. Looking Begin-Right.

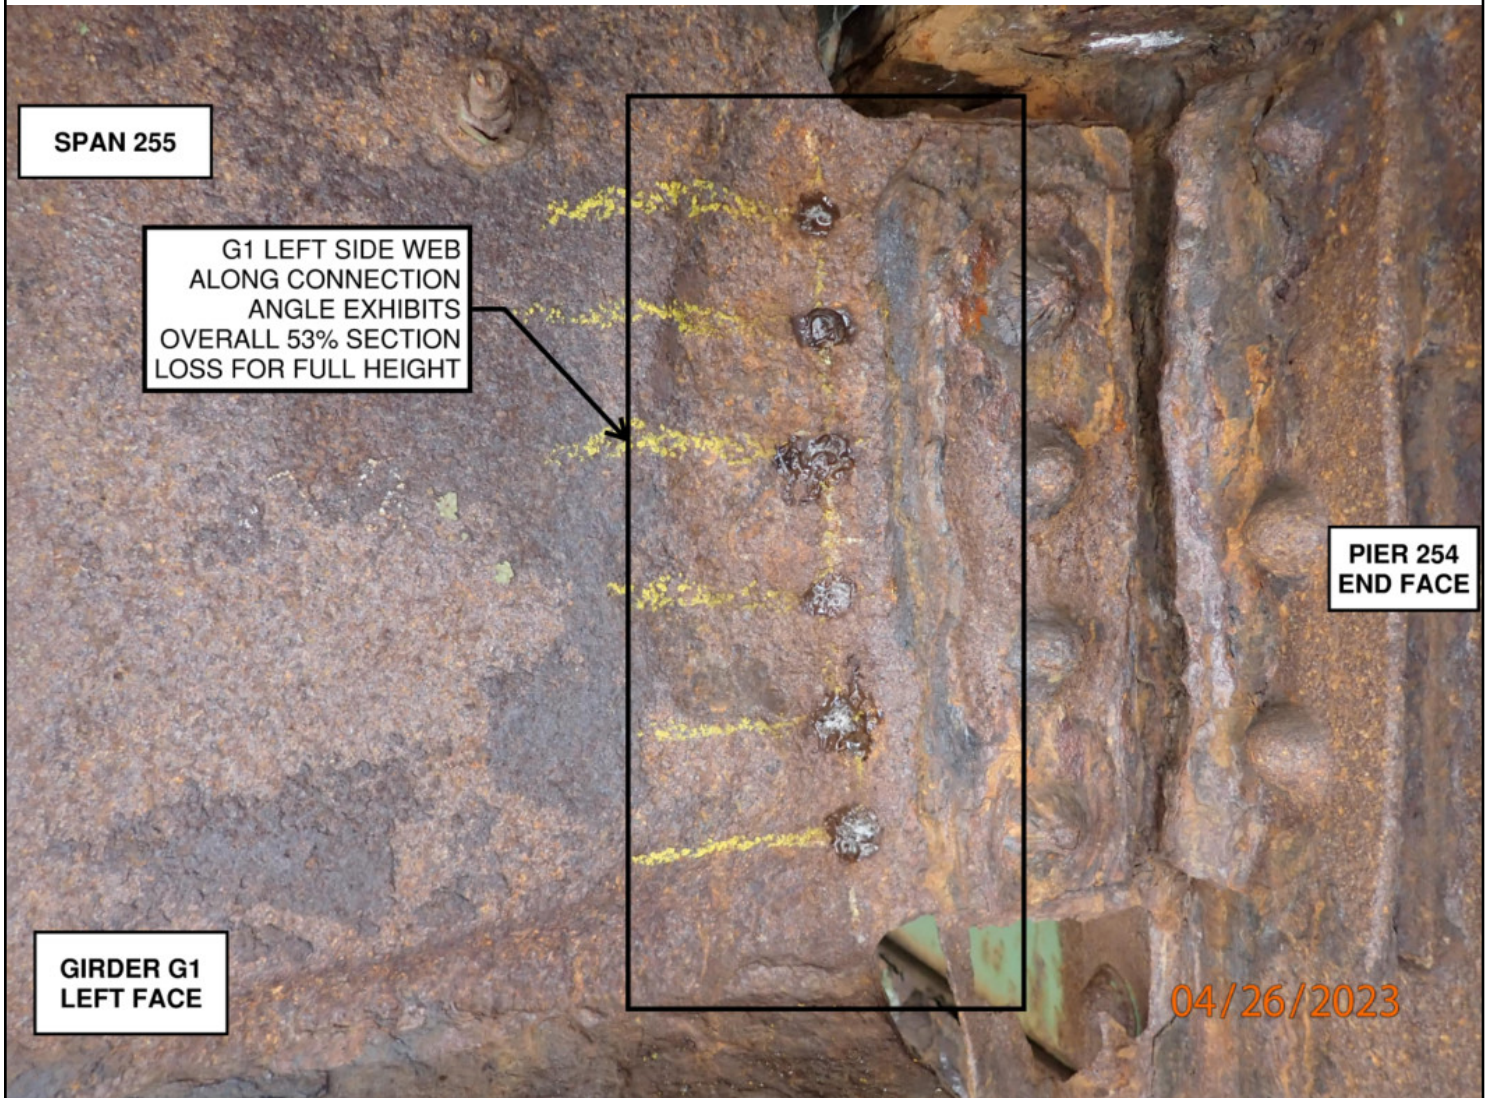
Photo Number: 6

Attachment Description: Close-up view of Girder G1 left side web along connection angle exhibits overall 54% section loss for full height x 1-3" wide. Looking Begin-Right.

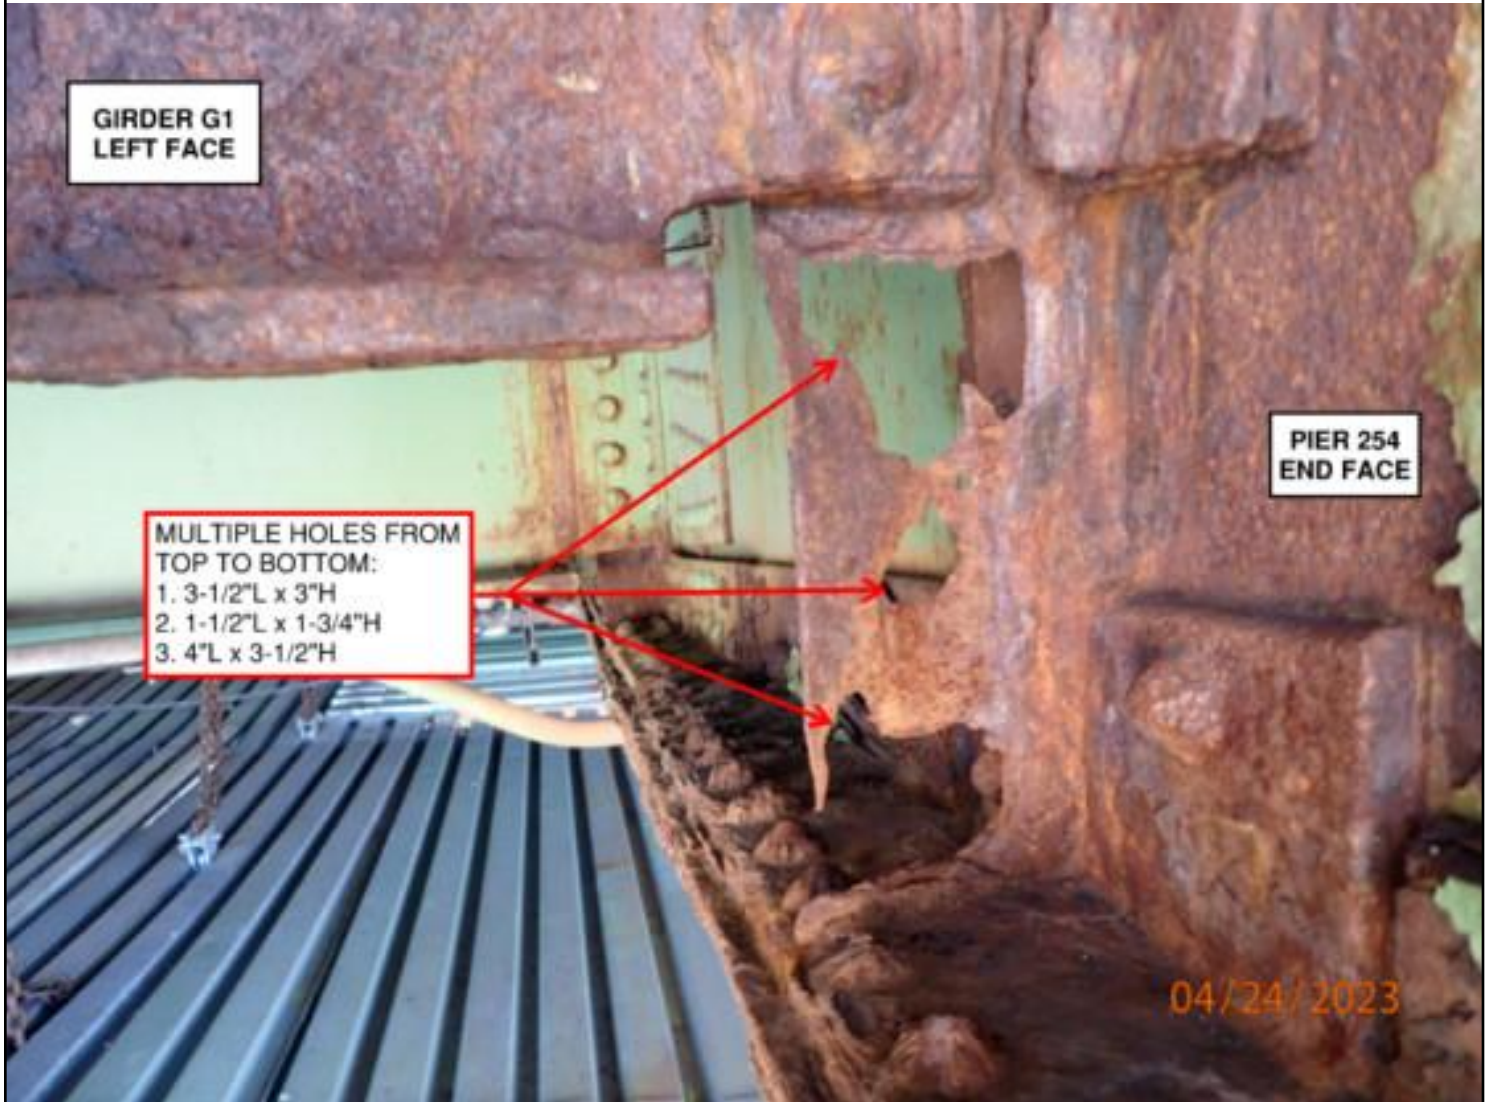
Photo Number: 7

Attachment Description: Close-up view of girder G1 right connection angle exhibits three corrosion holes measuring 3.5"L x 3"H, 1.5"L x 1.75"H and 4"L x 3.5"H. Looking Right.

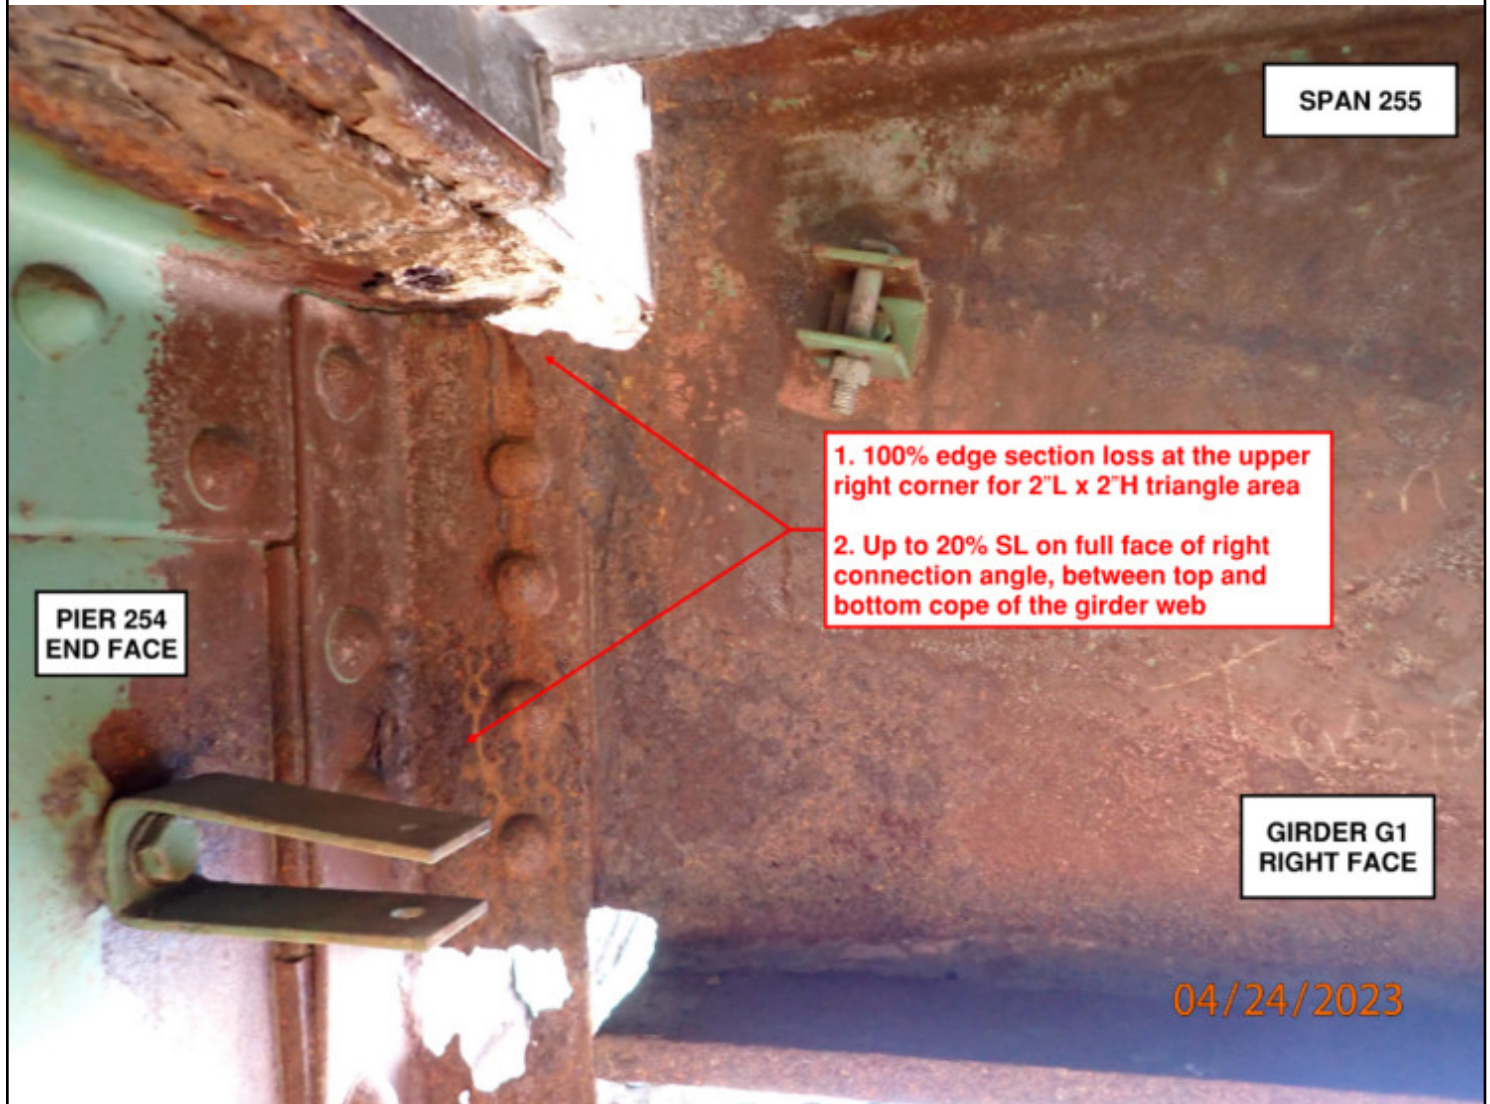
Photo Number: 8

Attachment Description: Close-up view of Girder G1 right connection angle. Connection angle from the bottom cope of the web of Girder G1 to the top cope of the web of Girder G1 has up to 20% section loss on full face with a 2"L x 2"H triangle area exhibiting 100% section loss in upper right corner. Looking Begin-Left
